THE MAN-MADE MCMURDO ICE WHARF--HISTORY, CONSTRUCTION AND PERFORMANCE

CIVIL ENGINEERING LAB (NAVY) PORT
HUENEME CALIF

FEB 1975

REPORT DOCUMENTATION PAGE		READ INSTRUCTIONS BEFORE COMPLETING FORM
1. REPORT NUMBER TN-1376	2. GOVT ACCESSION NO. DN144029	3. RECIPIENT'S CATALOG NUMBER AD-A 007 527

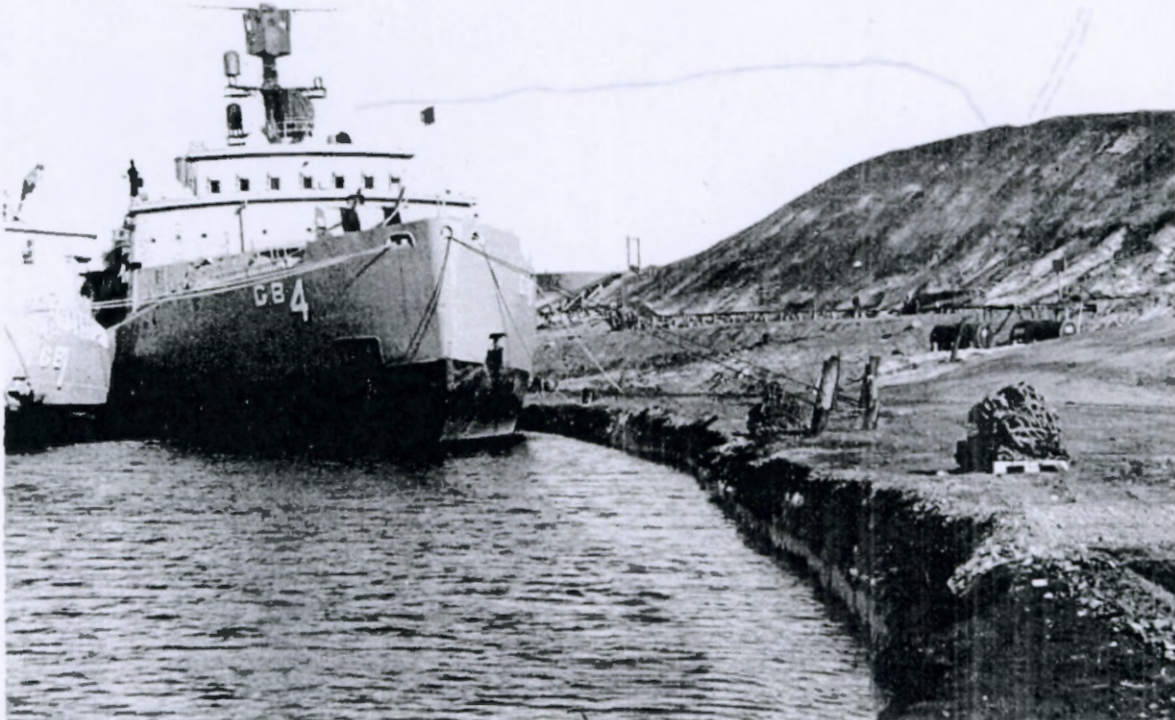
Figure 2 shows the smooth face of the ice shelf during DF-65. Unfortunately, removal of the annual ice around Hut Point was deleterious to wharf survival. The vertical face, no longer protected by a buffer of sea ice, was exposed directly to ablative melting caused by

Figure 2. View of the smooth, natural ice wharf face during DF-65.

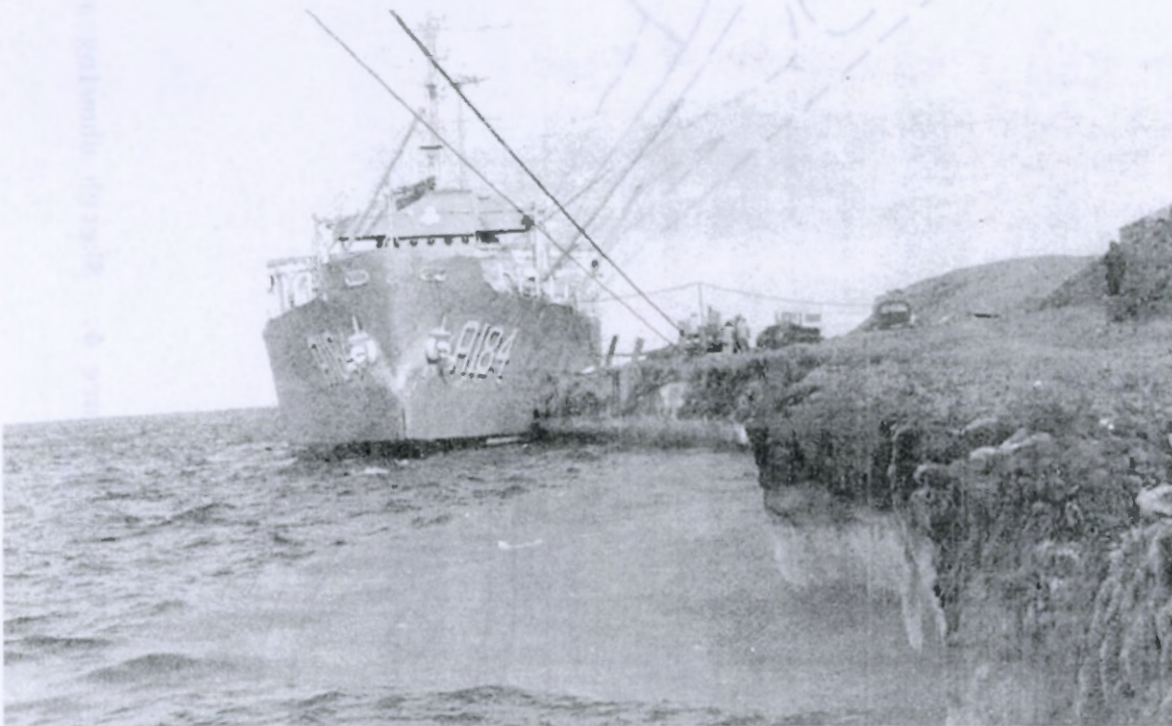
wave action and ship discharge. The result was undercutting. Melted caverns formed at sea level, creating cantilevered lips which would periodically break off unevenly, giving the vertical ice face a jagged and protuberant appearance. Figure 3 shows the effects of ablative melting. In 1969, it was estimated that each year 10,000 square feet of surface area was lost to wave action [3]. Even more serious than the loss of cargo-handling area, however, was the reduced depth of water alongside the wharf. Figure 4 shows how ablation along the seaward face caused the fast ice to recede into the shallower waters near shore.

Figure 3. Jagged appearance of ice face due to undercutting after DF-65.

In order to prevent further wave damage, and also maintain a vertical docking surface, the Naval Facilities Engineering Command (NAVFAC) designed a protective dock face. In a 4-year period ending in DF-72, a total of 464 feet of steel and timber facing was installed [4]. Structural beams, placed on the wharf and anchored to piles set in the ice, were used to support a vertical, steel framework with timber panel inserts. This network, which extended from approximately 10 feet above sea level to 20 feet below, prevented wave penetration. A volcanic fill material was packed between the facing and natural ice face to provide additional protection. Figure 5 presents a closeup view along a section of the dock facing. During March 1972, a major portion of the wharf was either destroyed or severely damaged by storm. High tides and pounding ice ripped out many of the steelfaced timber panels, bending the I-beam supports and washing away most of the fill. Unprotected portions of the natural ice face were extensively eroded.

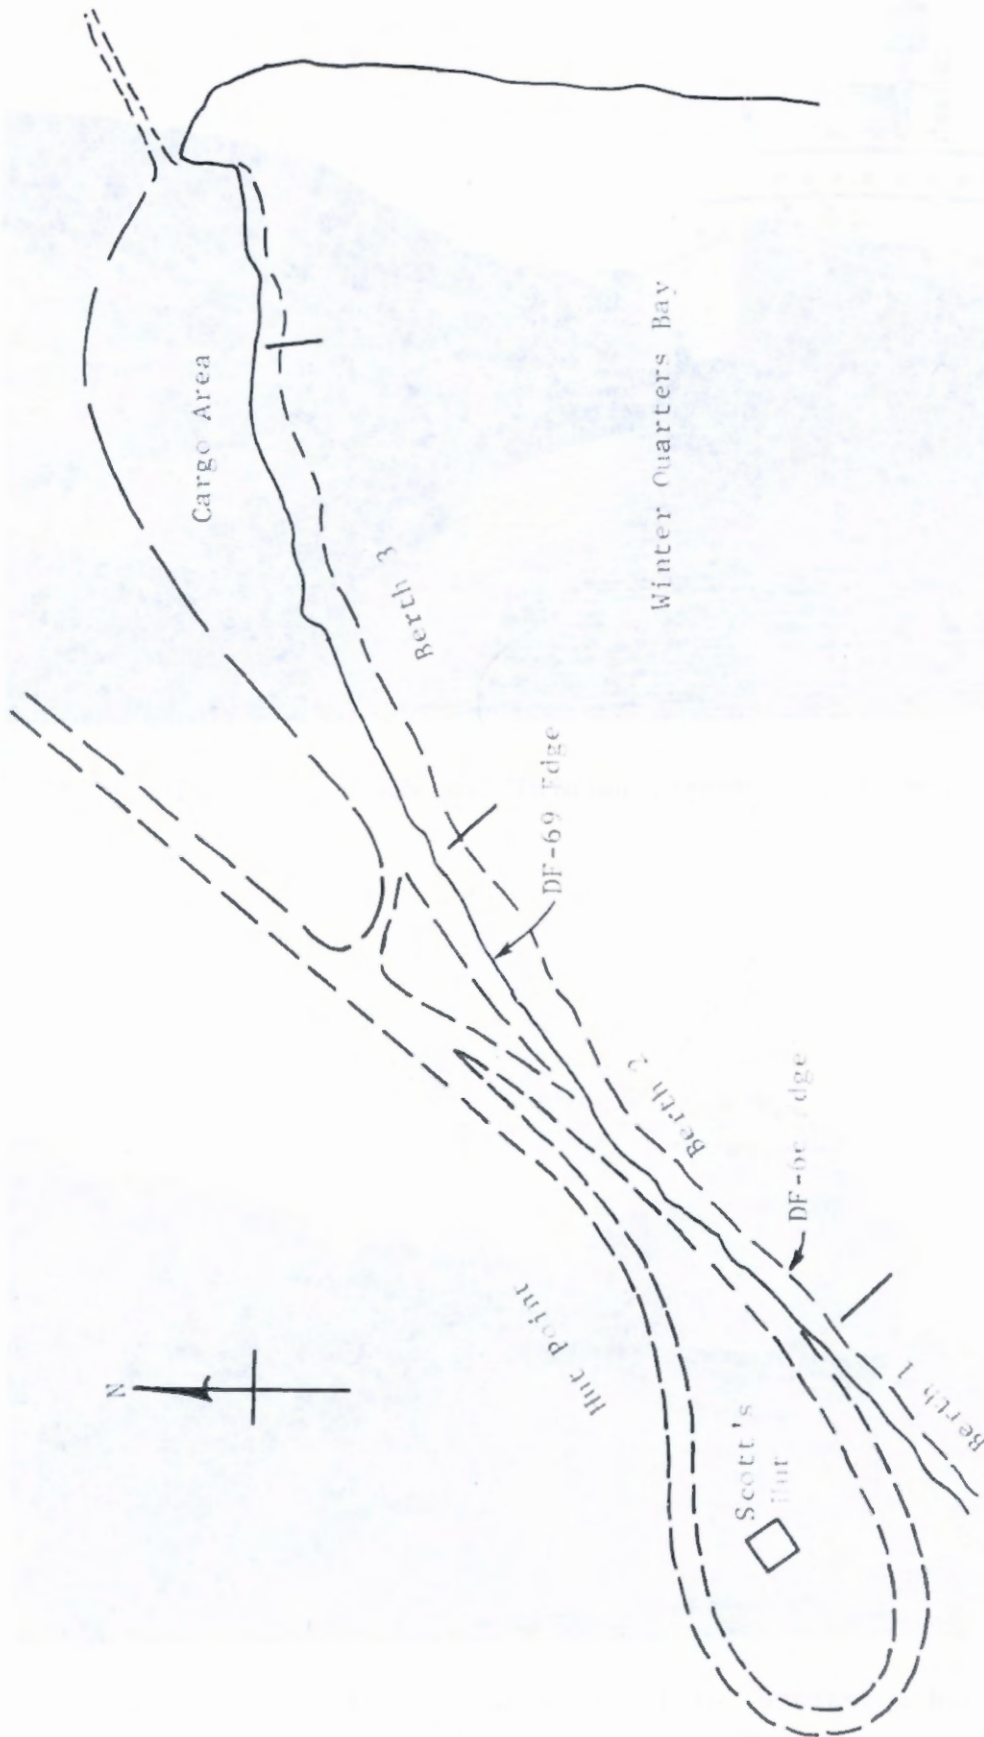
Figure 4. Sketch showing ablation history of natural ice wharf.

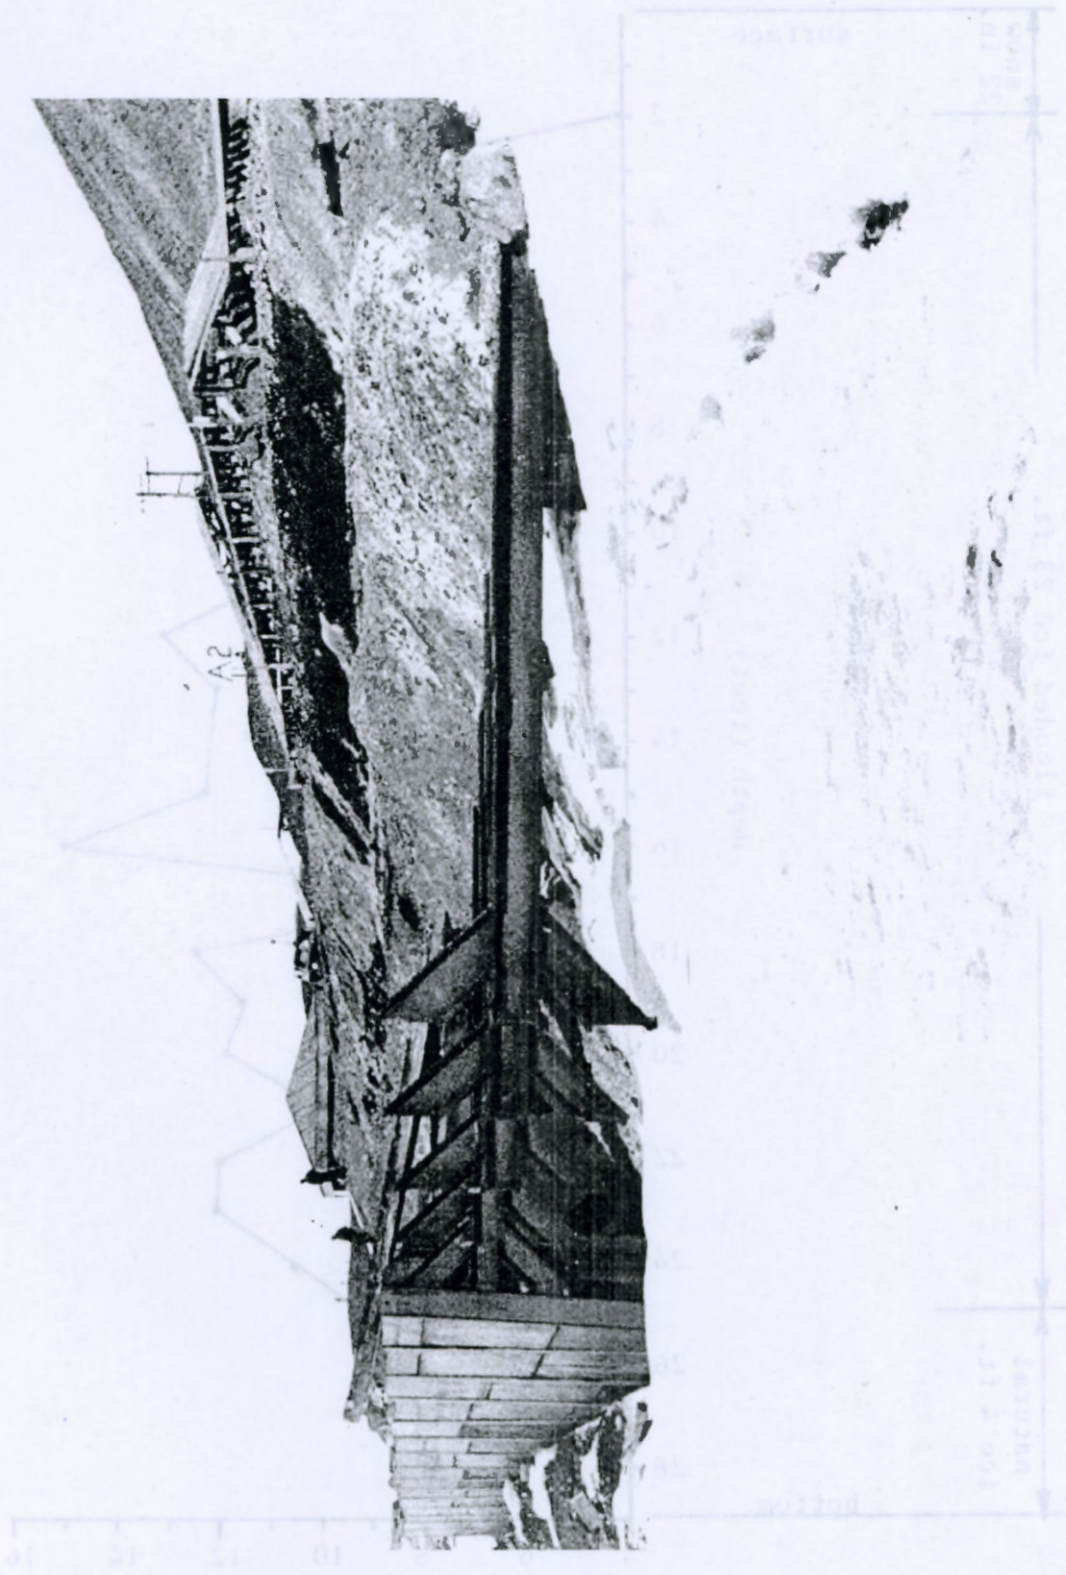
In addition to the problem of a damaged ice dock, submerged debris littered the shipping channel and berthing area. Remedial measures were necessary. A temporary solution was conceived by engineers from NAVFAC who visited McMurdo in December 1972. From their plans, steel workers were able to reconstruct from sections of the original dock structure two piers, 70 and 60 feet long respectively, which extended 5 to 10 feet farther out into Winter Quarters Bay than the previous installation. Two cargo ships (the 18-foot draft *USNS Mirfak* and later the 24-foot draft *USNS Private John R. Towle*), were able to unload from this temporary facility with only minor inconvenience.

Figure 5. Construction of the steel-and-timber dock sections.

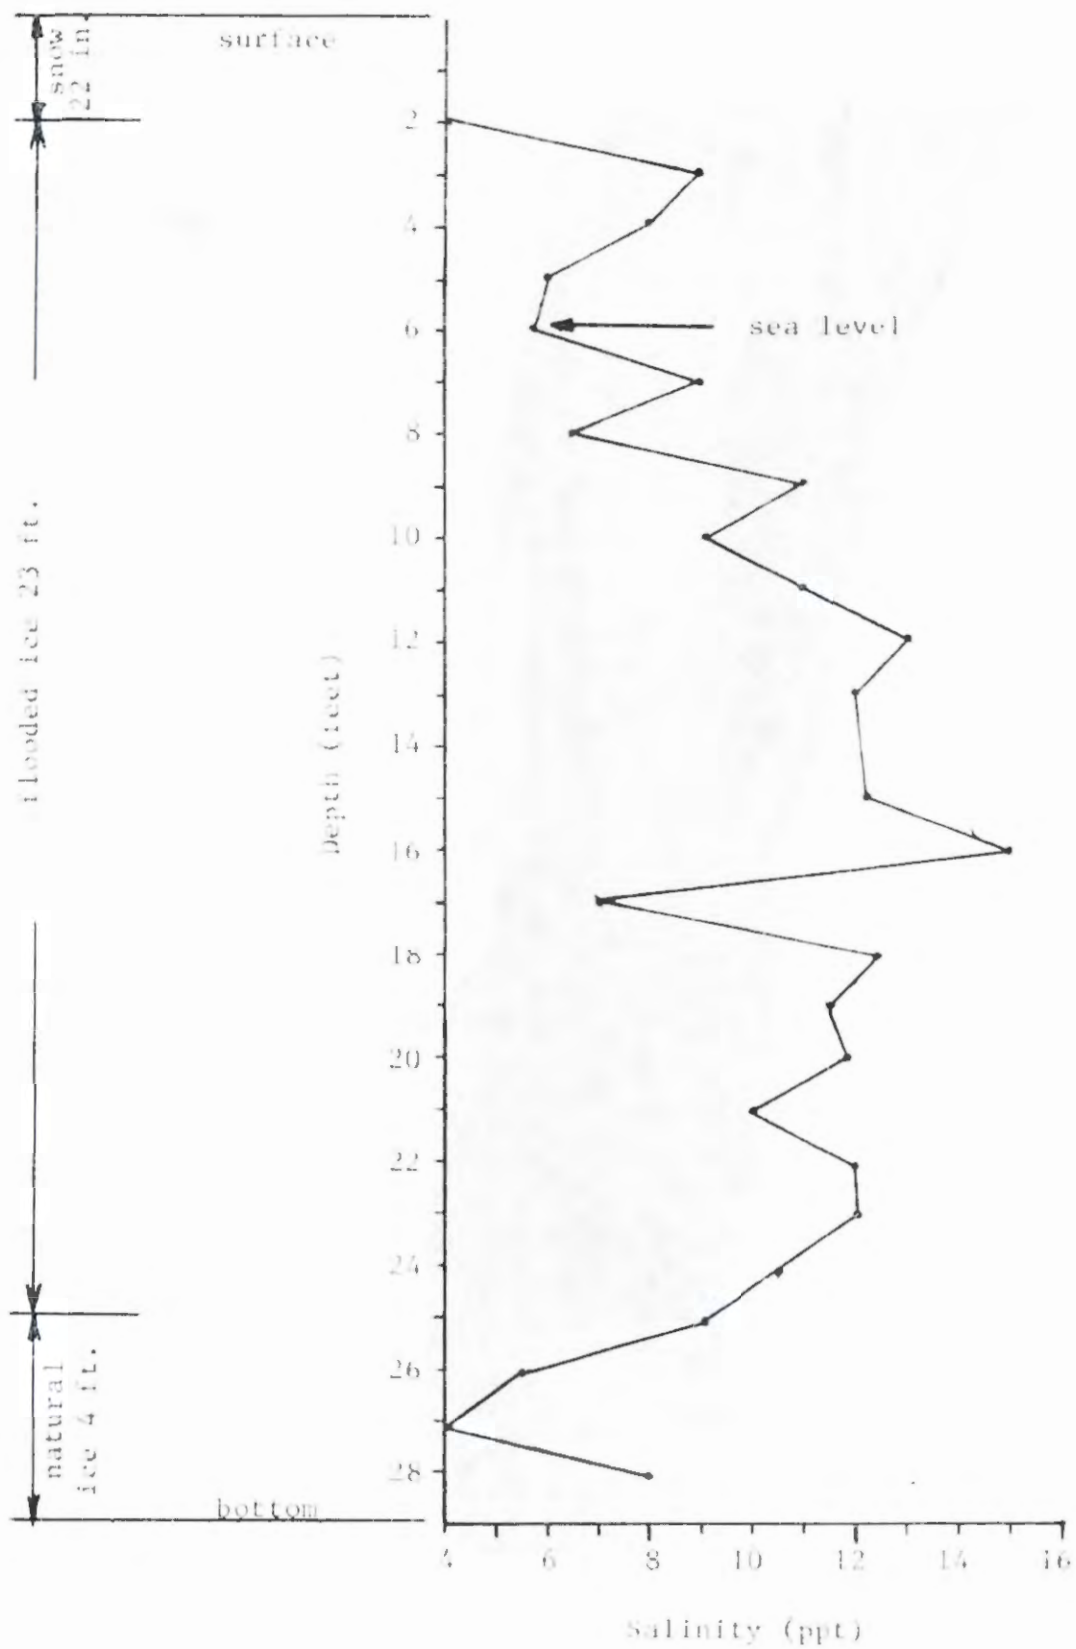
The results of the salinity measurements made at 1-foot intervals are shown in Figure 6. The highest salinity measure was 15 parts per thousand (ppt) with an average of 9.7 ppt. This was about twice the average salinity for 1-year-old sea ice but again was considered normal for the flooded ice at that time.

Figure 6. Salinity profile of core extracted from surface-flooded ice wharf, 25 November 1973.

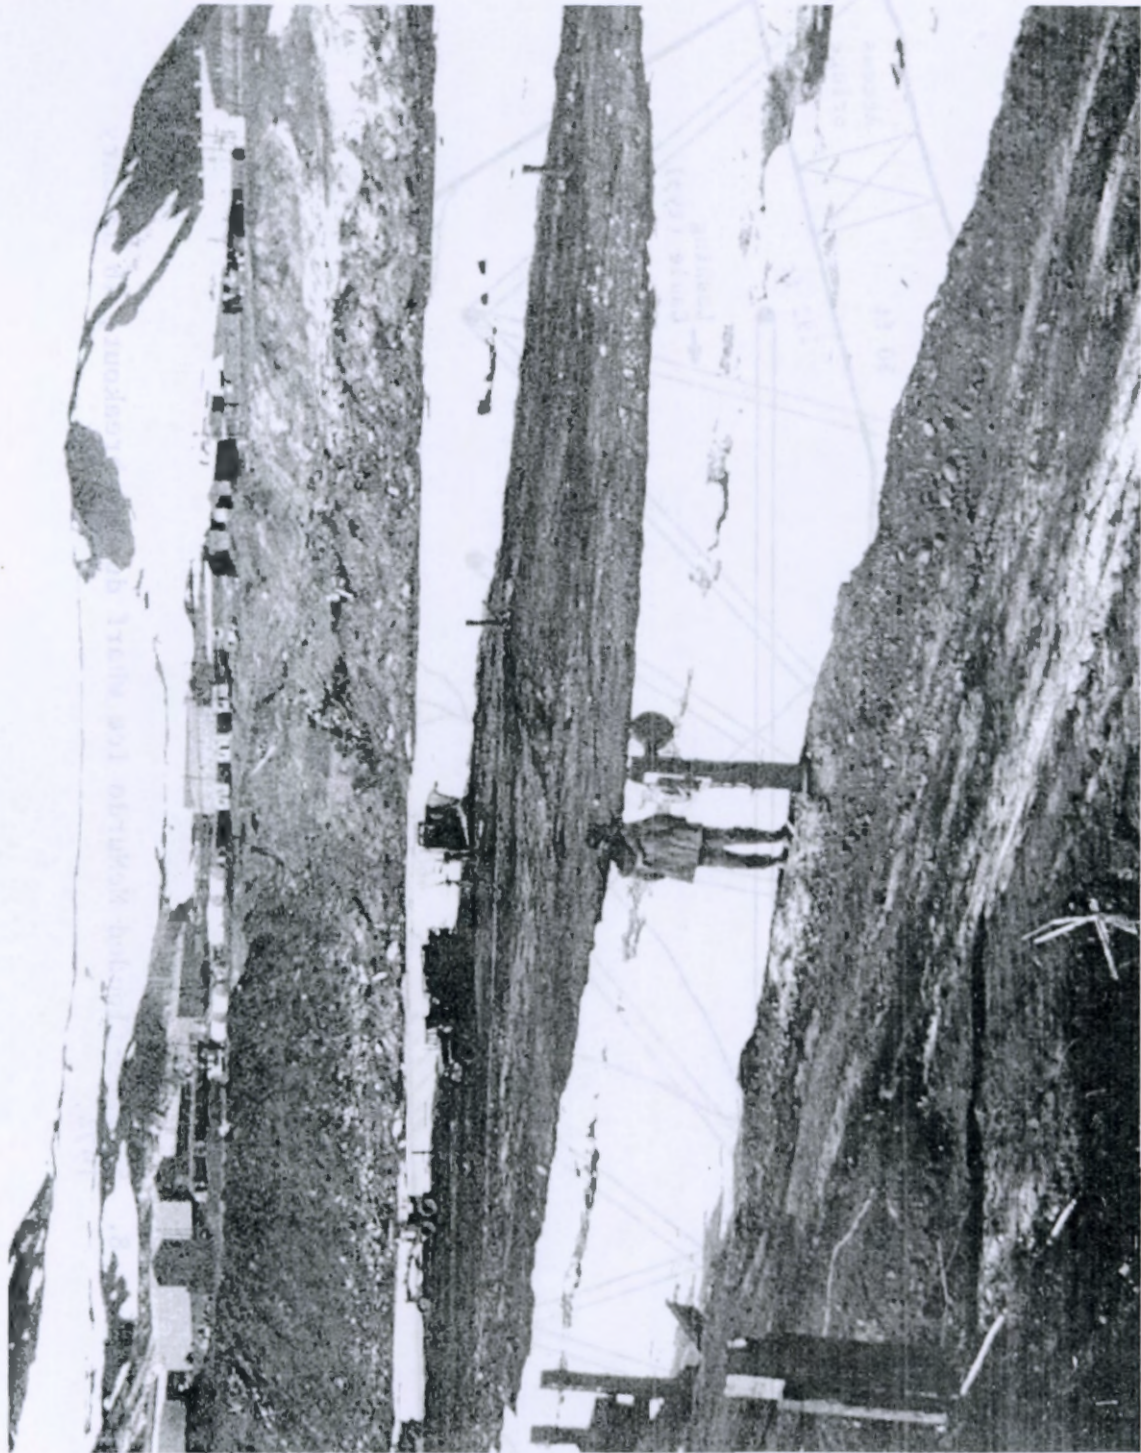
annual ice from the vertical seaward face. Figure 7 pictures the structure prior to breakout attempts. It was agreed that a weakened interface should be formed. A series of holes of 10-inch diameter, about 5-foot depth and located on about 5-foot centers was drilled in the annual ice at the construction interface.

Figure 7. Surface-flooded ice wharf just prior to breakout, DF-74.

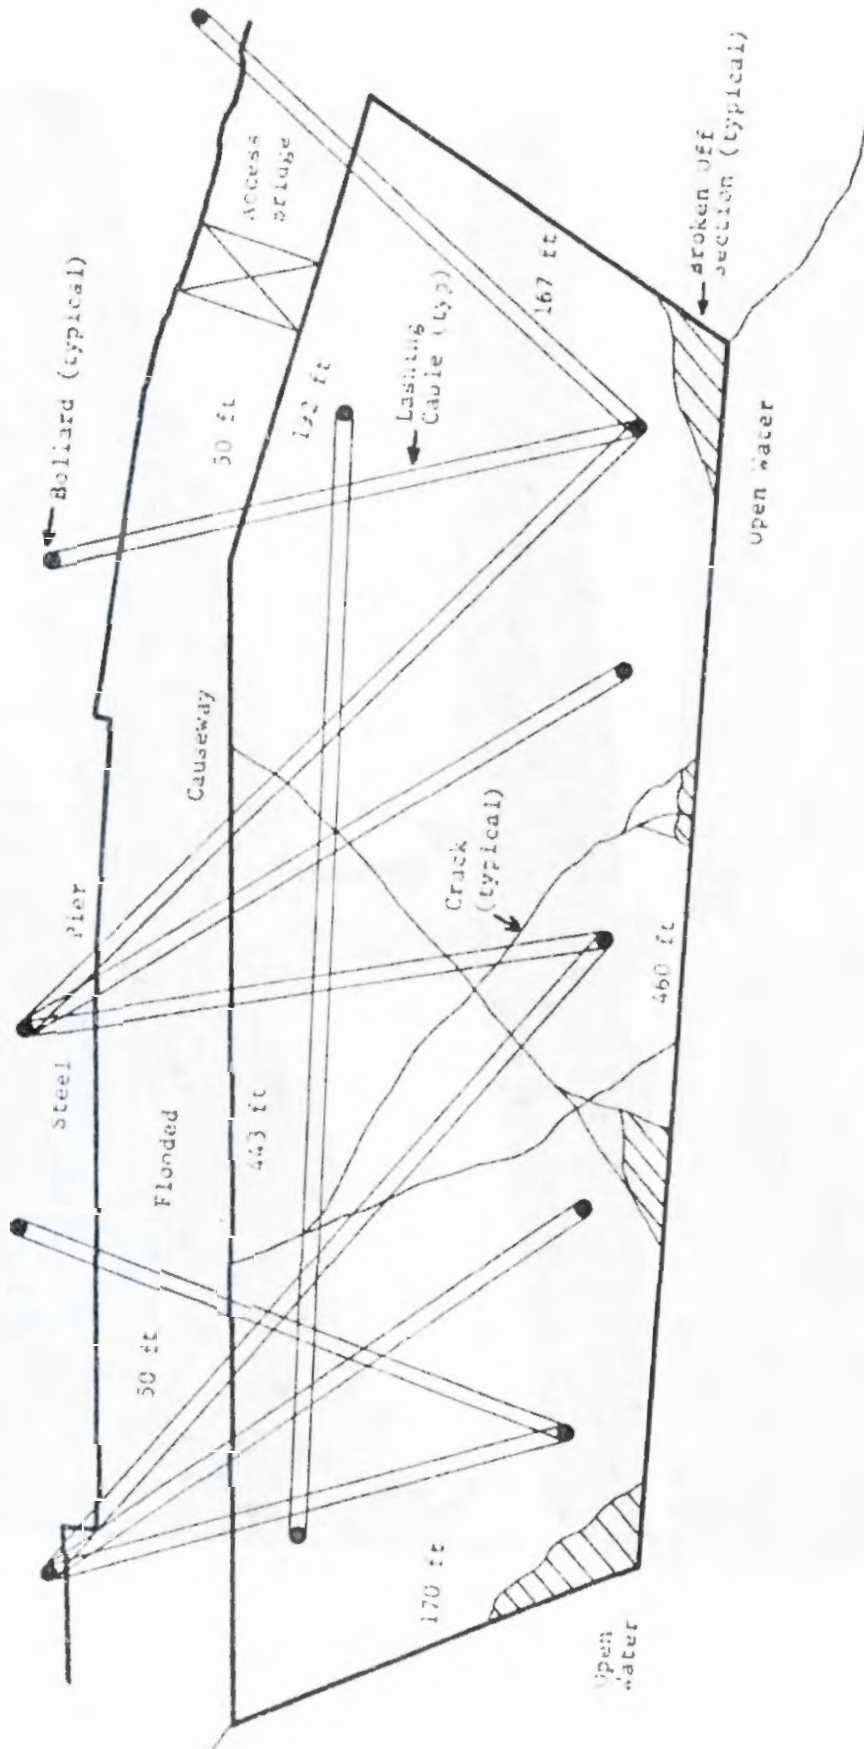
The ice breaker *USCG Staten Island* moved into Winter Quarters Bay on 15 January to remove ice from the vicinity of the wharf. Initial passes were intended to break up the annual ice at some distance from the structure. Even so, a crack which began in the annual ice continued to propagate through the wharf, all the way to the tidal crack. In addition to this major full-depth crack, there were other hairline fractures. Operations were halted and two bollards installed in order to tie the two sections together.

The next day the ice breaker resumed maneuvers. It made good progress on clearing the wharf face. On the last pass, however, the ship moved too closely, and the resulting impact opened up several new full-width, full-depth cracks. Also, an end piece totally separated and floated away. The remaining sections were large and worth saving; two additional bollards (for a total of seven) were added, and the entire network lashed together. Figure 8 presents a sketch which shows crack and bollard configuration at the time of cargo unloading.

Figure 8. Surface-flooded McMurdo ice wharf during breakout, 16 January 1974.

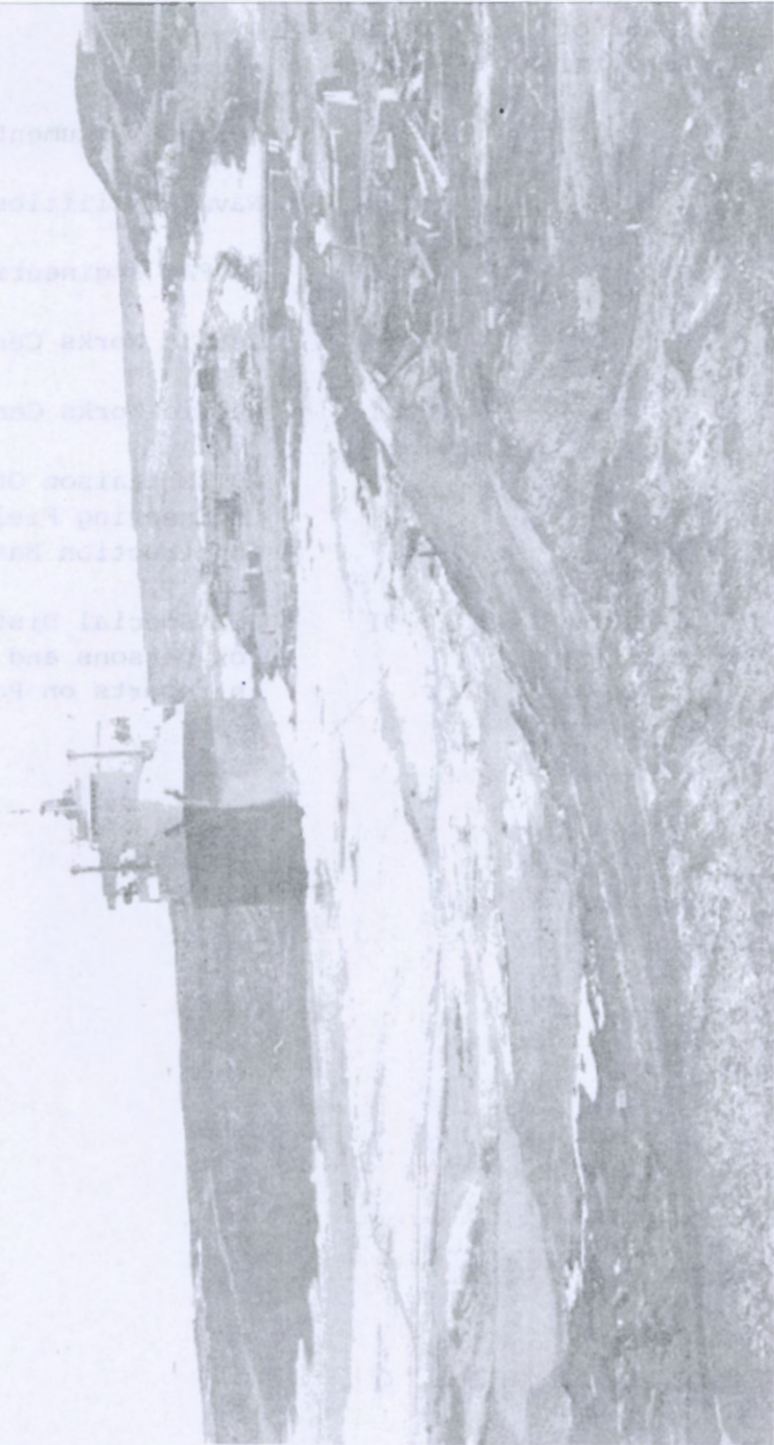
The ice wharf proved to be a very effective facility for cargo handling once the seaward face was adequately cleared. The *Towle* (Figure 9) was successfully unloaded twice in DF-74, during January and during the return visit in February. In addition, oil was discharged in late January from the tanker *Maumee* as she was berthed alongside the giant ice structure. No major problems were encountered in the wharf itself. It provided a good, solid platform with an abundance of space for cargo handling and vehicle traffic. The cables effectively held all the separate pieces together, as well as the entire assembly against shore.

Figure 9. USNS Private John R. Towle docked against the man-made ice wharf, DF-74.
