## ANTARCTIC TREATY CONSULTATIVE MEETING 2006

IP 115

# Clean up of abandoned Cape Hallett Station.

## Information Paper submitted by New Zealand and the United States

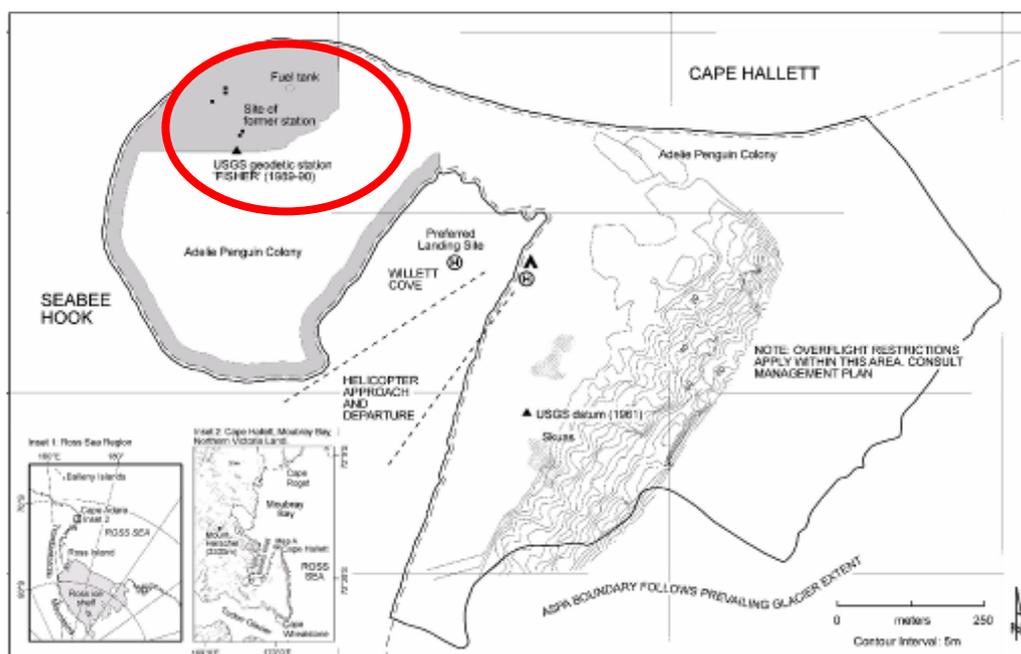
Figure 1. Seabee Hook, Cape Hallett, with the site of the joint New Zealand / US station circled in red.

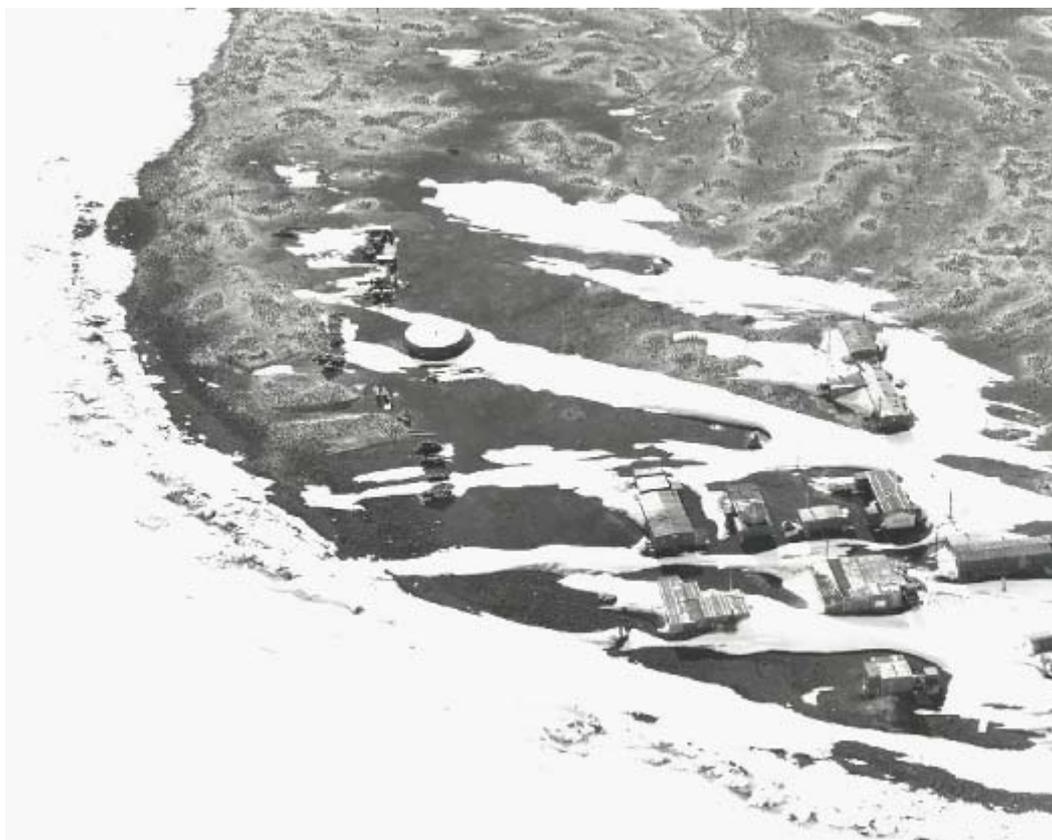
Figure 2. Cape Hallett station in 1973 prior to the initial clean up work.

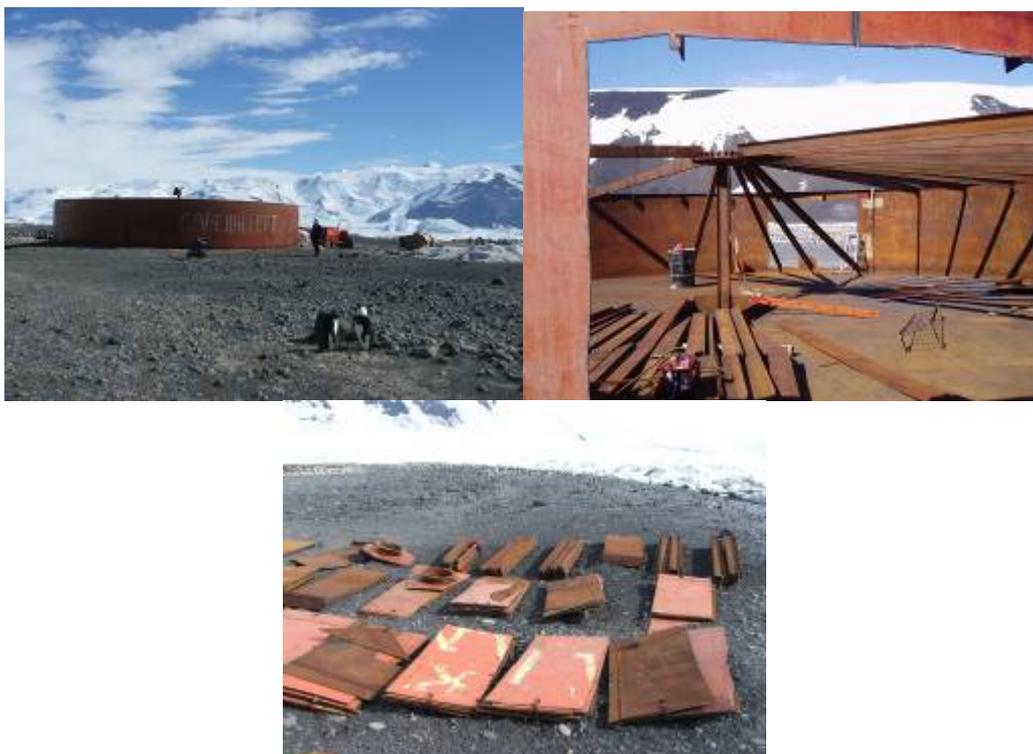
Figures 4,5 and 6. Fuel tank prior to dismantling; dismantling in progress; sections of fuel tank ready for helo lifting to the *Italica*.

Over a period of six weeks, the 100,000 gallon bulk fuel tank and 10, 800 gallon day tanks we opened, vented and dismantled. No contaminants were released as a result of the tank dismantling. See figures 3,4 and 5.

The tank dismantling and on-site clean up of debris resulted in a further 91 tonnes of material staged for removal from the site (mostly steel plates and beams). Again generous support from the Italian Antarctic Programme in making their vessel *Italica* available allowed the vast majority of these materials to be removed. At the end of the 2005/06 season only 20 tonnes of materials (mostly steel plate from the fuel tanks) remains on-site. This will be removed at the earliest opportunity.
