MONOGRAPH

Construction, Maintenance, and Operation of a Glacial Runway, McMurdo Station, Antarctica

George L. Blaisdell, Renee M. Lang, Gerald Crist, Keith Kurtti, R. Jeffrey Harbin, and Daniel Flora

March 1998

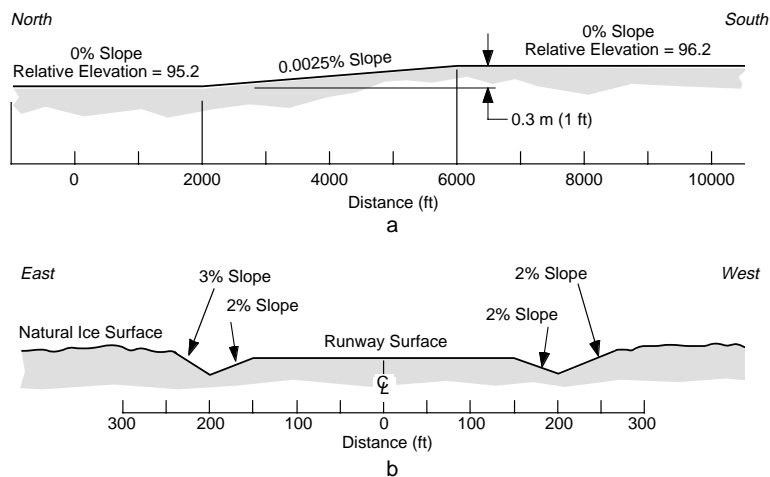
Figure 43. Final grade plan for the Pegasus runway.

The final grade for the Pegasus runway was set in three segments (Fig. 43). Each of these segments was designed to exactly match elevation at their intersection points, although this would not have been necessary (steps of as much as a few centimeters would not have caused any distress to the aircraft for which we designed). Two of our segments

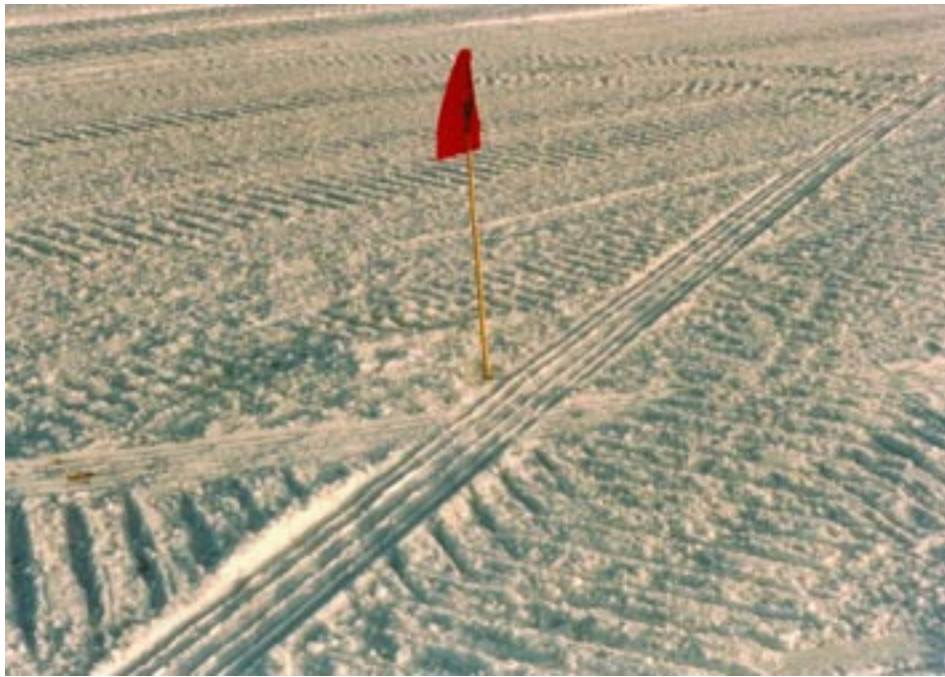
Figure 62. Tracks of proof cart on area patched 48 hours earlier.

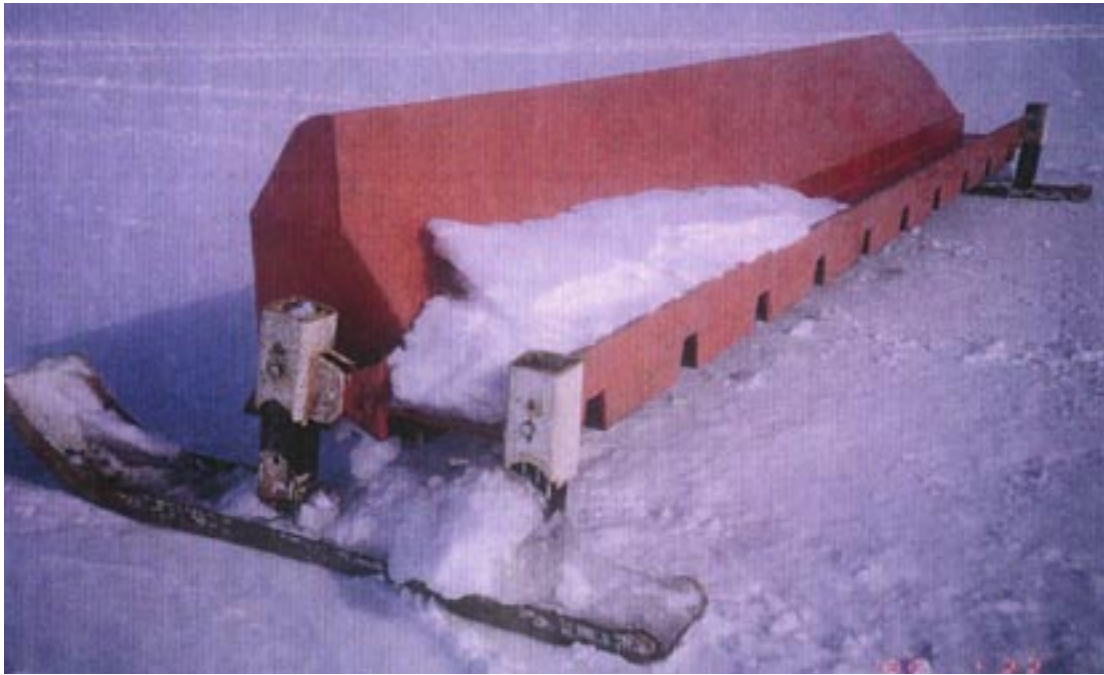
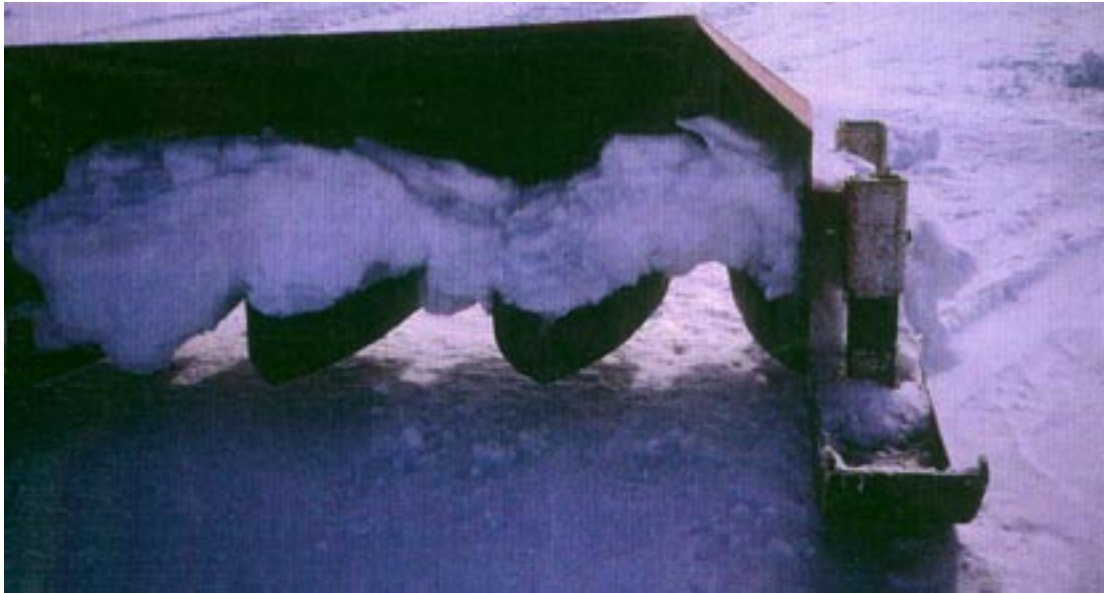
Figure 68. Windrow drag used to encourage snow accumulation.

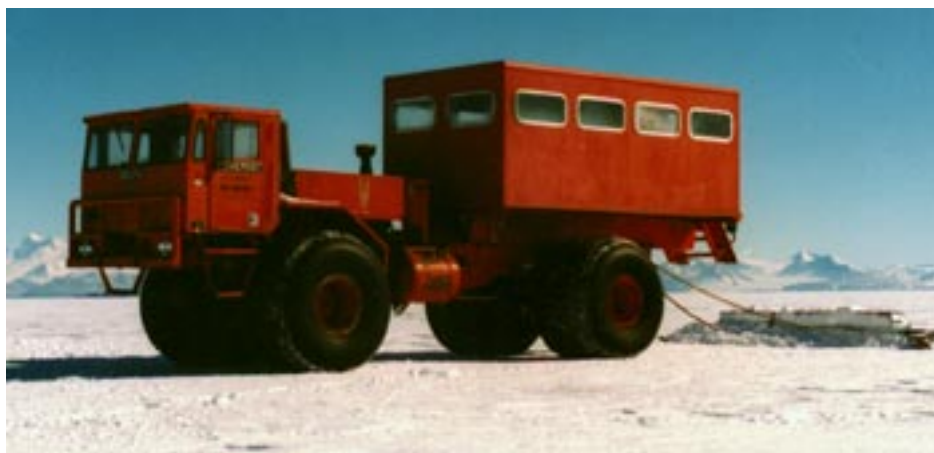
Figure 73. Drag made from heavy I-beam.
